## BASSnet 2.11 SP2 Hotfix 2-003 Patch Release Notes

<b>Product:</b>	BASSnet™ 2.11 SP2
<b>Release Number:</b>	BN2.11 SP2 HF2-003
<b>Release Date:</b>	18 August 2023
<b>Customer Support:</b>	For more information or support, please visit our website <a href="http://www.bassnet.no/">http://www.bassnet.no/</a>

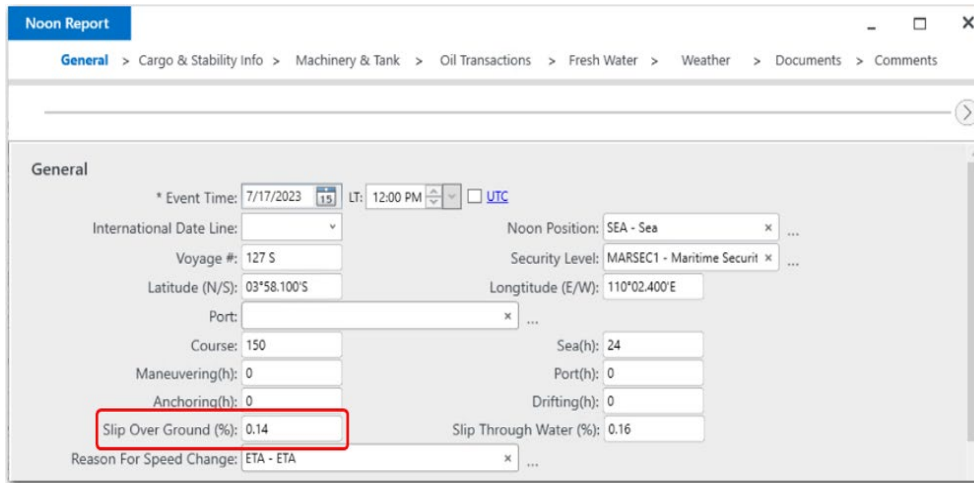
This issue has also been resolved in **Ship Log – Noon Report** under the **General** tab, where the **Slip Over Ground (%)** field was not multiplied by 100.

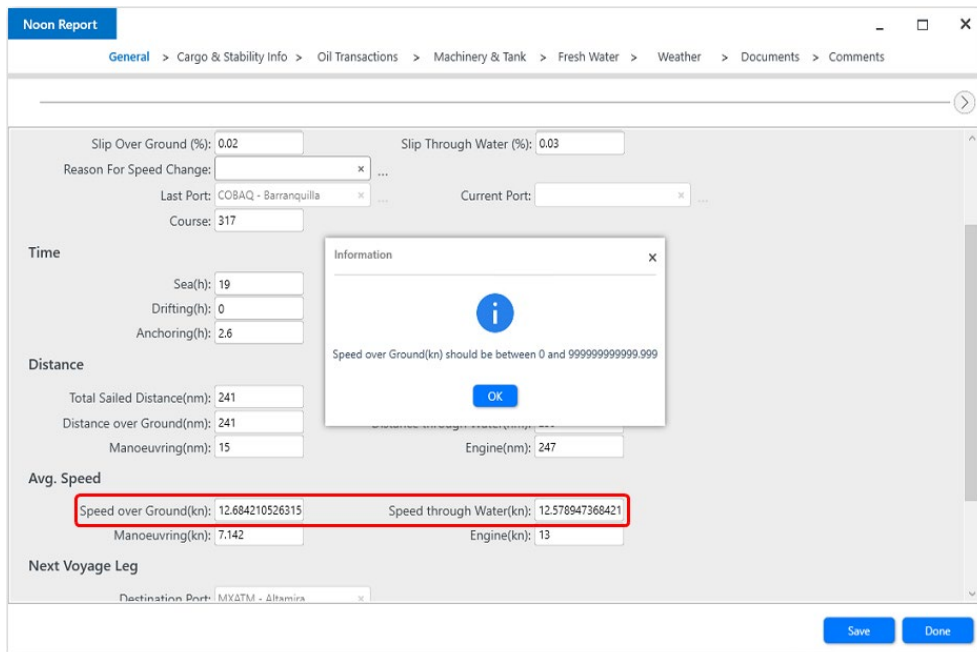
- ❑ [Defect 78323] Resolved an issue in the **Ship Log** sub module where more than three decimal points were auto added to the values for certain fields, such as the **Speed Over Ground (kn)** and **Speed through Water (kn)** fields in the **Noon Report** when the **Sea (h)** field was updated, which then prompted the following validation message when the Noon Report data was saved.
